DEFECT DETECTION AND SIZING TRIALS USING THE TOTAL FOCUSING METHOD AND SCATTERING COEFFICIENT MATRIX WITH A LINEAR PHASED ARRAY

S. Wedge, L. Carter, A. Rogerson
NDT, AMEC Clean Energy, UK
J. Zhang, B. Drinkwater, Bristol University, UK

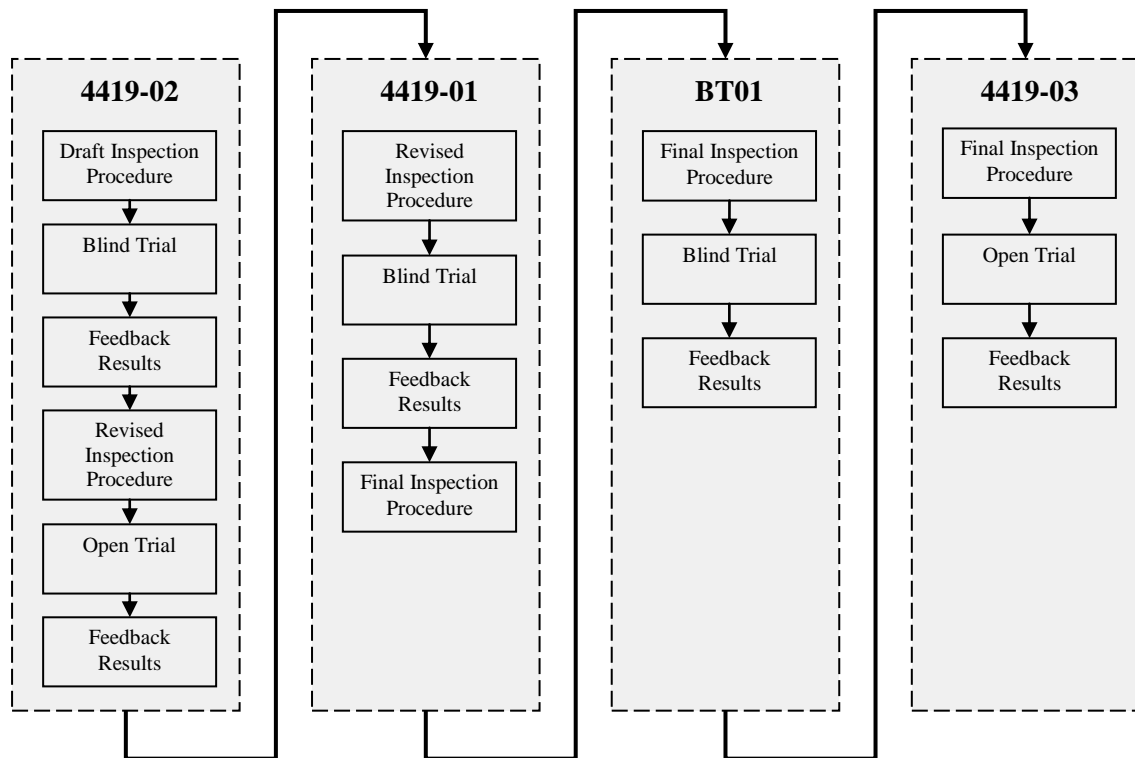
Figure 2: Flowchart of the Inspection Procedure Design and Testing Process

Figure 2 depicts the flow of the development trials on each of the four test samples. Feedback was provided following the inspection of each sample, which was used to develop the procedure prior to the next stage.

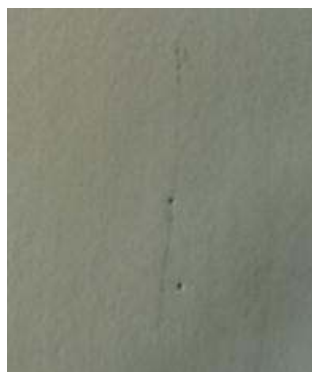
Figure 5: Destructive examination of Defect F in Specimen 4419-02 / BT01

Defect F is intended to be a vertical rough crack 10 mm in length and 2.3 mm through-wall. The destructive examination of this defect can be seen in Figure 5. The through-wall extent of this defect was observed to be 1.49 mm. The gape of this defect is observed to be very tight, which would act to reduce the ultrasonic reflection at certain areas of the defect. The roughness is not clearly observed in this plane.

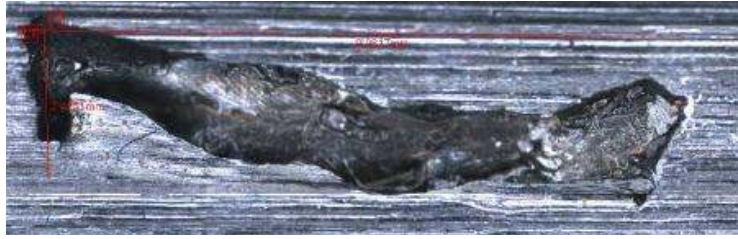
Figure 6: Destructive examination of Defect G in Specimen 4419-02 / BT01

Defect G is intended to be a horizontal line of slag 10.1 mm in length and 2.5 mm in diameter. The destructive examination of this defect can be seen in Figure 6 which depicts a cross section along the length of the defect. The true length is 9.52 mm and the through-wall extent was observed to be 2.45 mm.

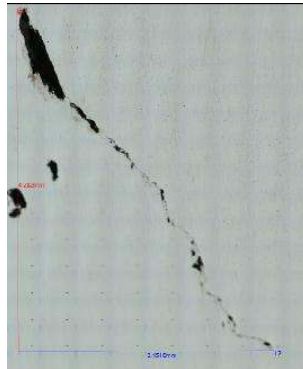
Figure 7: Destructive examination of Defect H in Specimen 4419-02 / BT01

Defect H is intended to be a rough crack 21.5 mm in length and 5.4 mm through-wall tilted at 30°. The destructive examination of this defect can be seen in Figure 7. The through-wall extent of this defect was observed to be 4.28 mm and tilted at 36.3°. Its rough nature can be clearly observed.
